PHASE I **ENVIRONMENTAL SITE ASSESSMENT**

PROPOSED STOREASE SELF STORAGE – HAMPTON COVE **ROUNDBAR DRIVE AND HIGHWAY 431 HUNTSVILLE, ALABAMA, 35763**

OMI Job No. 9678

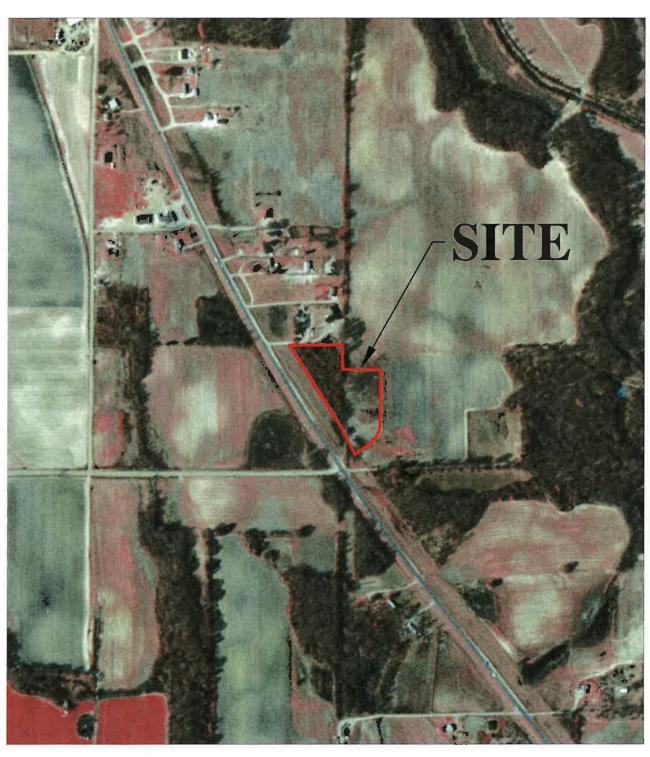
1981 (Drawing 9678-6, Scale 1 in = 500 -ft)

The subject site and adjoining properties appear similar to the previous photograph; however, the residential structures previously shown on the subject site and southeastern adjoining property are shown removed.

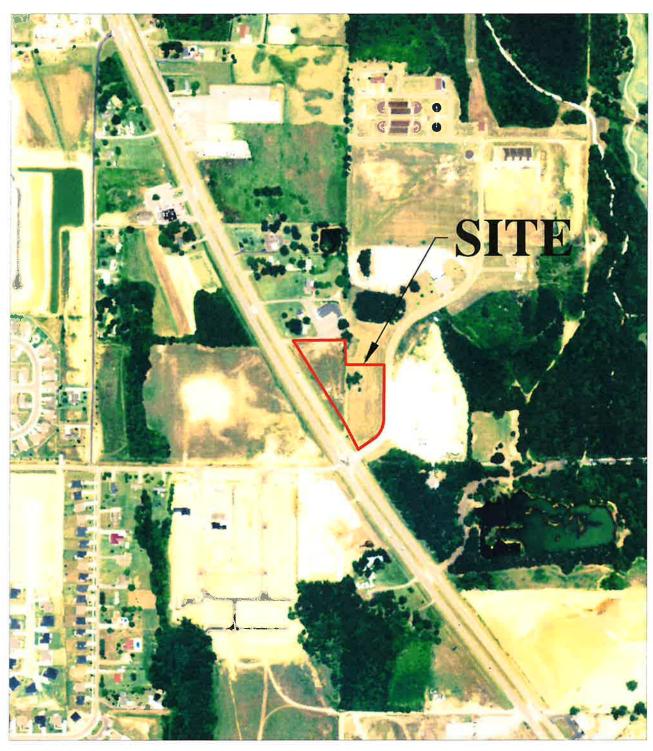
2006 (Drawing 9678-8, Scale 1in = 500-ft)

The majority of the woodland areas previously shown on the subject property are shown cleared with a copse of trees shown on the northwestern portion of Tract 2. Alabama Concrete is shown on the eastern adjoining property. The western adjoining property appears as if earthwork has been performed. Additional commercial and residential development are shown in the general vicinity.

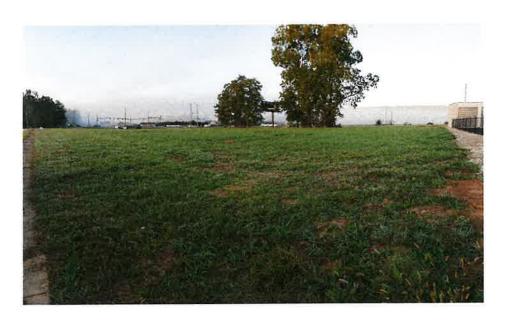
PHOTOGRAPH 1: Looking southwest from the northeast corner of the property.

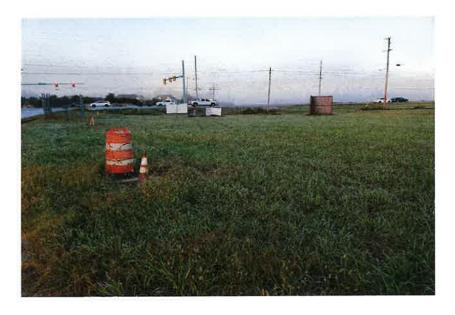
PHOTOGRAPH 2: Looking west from the southeast corner of the property.

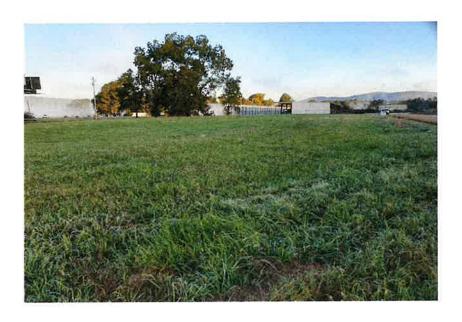
PHOTOGRAPH 3: Looking north from the southeast corner of the property.

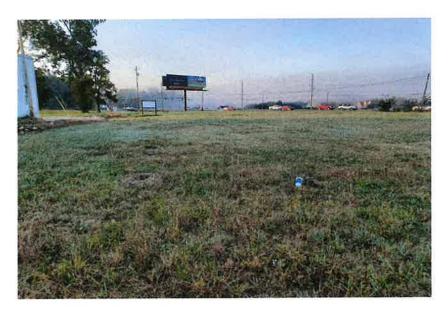
PHOTOGRAPH 4: Looking south from the northwest property boundary.
